# SkillsUSA Automotive Refinishing Technology National Championships -Featheredge, Prime, and Block Scenario-

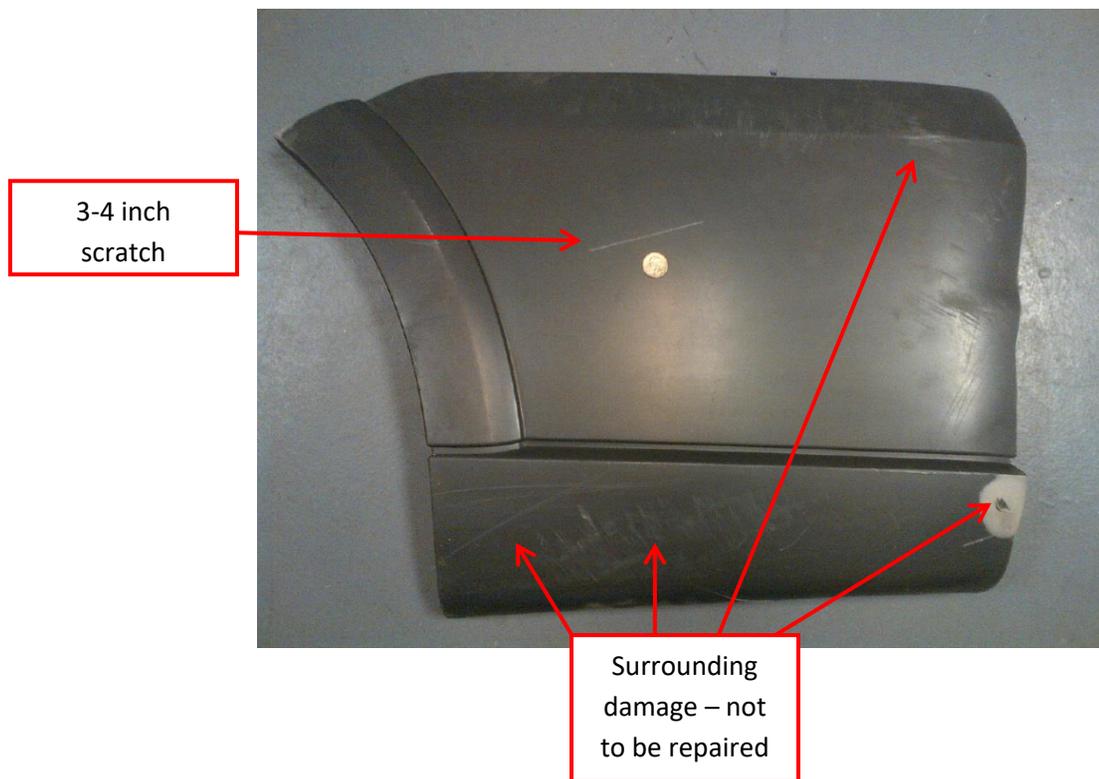
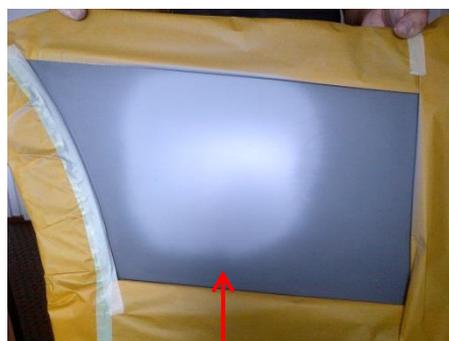
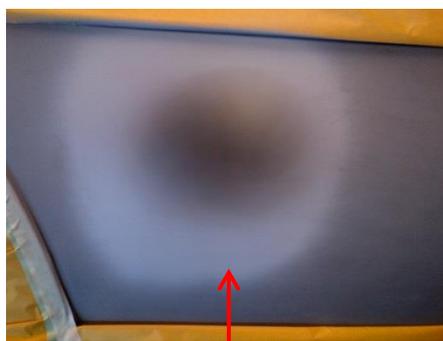
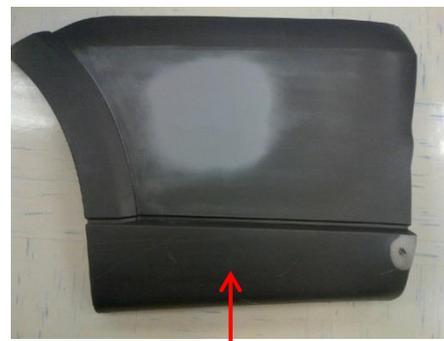
- Cleaned with waterborne cleaner
- Featheredge scratch with P180
- Surrounding edges were sanded with P320
- Apply UV primer surfacer and properly cure using UV light.
  - For proper flash, cleaning and UV Curing times, refer to the paint manufacturer's Technical Data Sheet.
- Guide coat was applied
- Repair area was blocked with P320
- Entire section was sanded with P600
- Final clean entire section

The repair area was completely smooth with no break-through in the primer.
